PROPERTY INSPECTION REPORT

REPORT #12-037

DATE: 5/7/2012 START TIME: 9:00AM END TIME: 2:15PM
FEE: 395
RADON: NO RADON COMPANY: N/A
PRESENT: CLIENTS AT 10:00AM TILL 1:00PM; BUYER AGENT 12:00 TO 1:00PM; HOMEOWNER AT 1:45PM
WEATHER: RAIN, 50'S
MISC:

YEAR BUILT: 2005
SQ FEET: 4456
 BASEMENT
 CRAWL SPACE
 CELLAR
 DETACHED GARAGE
OCCUPIED: YES
ORIENTATION: FRONT FACES NORTH

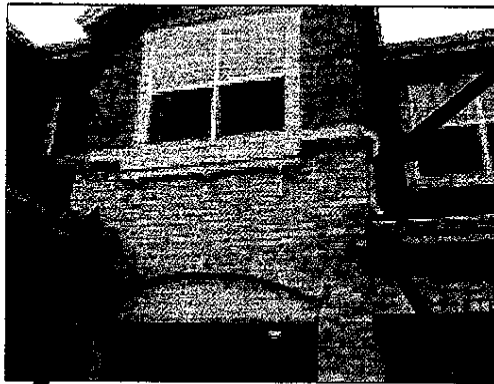
Picture #5

- (C) **PICTURE #5**. WHERE BRICK MEETS THE EXTERIOR WALL – THE 1/2-INCH SPACE BETWEEN THE LOWER SECTION OF BRICK AND THE SIDING WAS SEALED WITH CAULK. CAULK IS INCOMPLETE AND GAPS PERMIT WATER INTRUSION.

- (D) **PICTURE #5**. WHERE BRICK MEETS THE EXTERIOR WALL – THE 1/2-INCH SPACE BETWEEN THE UPPER SECTION OF BRICK AND THE SIDING WAS NOT SEALED. LARGE HOLE CAN PERMIT WATER INTRUSION/DAMAGE.

- REPAIRS:
 - (J) CAULK ALL OBSERVATION LOCATIONS TO PREVENT WATER INTRUSION, INCLUDING CRACKS IN THE MORTAR JOINTS.
 - (K) REPLACE SEPARATED MORTAR BETWEEN THE BOTTOM BRICKS AND THE ROOF SURFACE WITH APPROPRIATE CAULK.

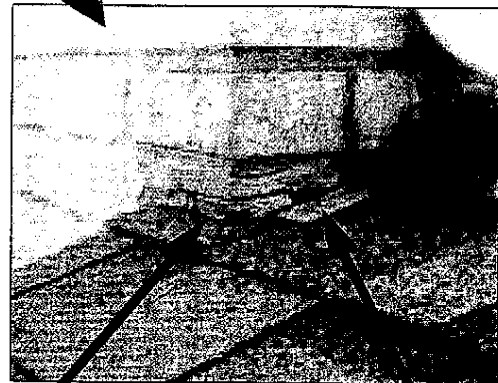
Picture #8

- (E) **PICTURE #8**. INDICATES FLASHING INSTALLED BETWEEN THE BRICK AND THE ROOF SURFACE. THIS FLASHING SHOULD BE PRESENT ALONG THE ENTIRE JOINT BETWEEN THE BRICK AND ROOF SURFACE ON BOTH THE INDICATED RIGHT HAND SIDE LOWER ROOF ABOVE THE GARAGE. THIS SHOULD BE STRICTLY FOR A FINISHED LOOK, NOT TO PREVENT WATER INTRUSION – THE FLASHING PREVENTS THAT. **SEE OBSERVATION F**.

- (G) **PICTURES #7 AND #8**. INDICATES LOCATIONS WHERE THE MORTAR BETWEEN THE BOTTOM BRICKS AND THE ROOF SURFACE IS CRACKED AND SEPARATING. THIS IS DUE TO WET CONDITIONS DUE TO CONTACT WITH THE ROOF SURFACE.
